Flood Control Project Maintenance
2019 Structure Summary Report
Overall Unit and Item Ratings

San Joaquin County Flood Control and Water Conservation District

Duck Creek Diversion Weir And Control Structure

Mormon Slough Pumping Plant No. 1

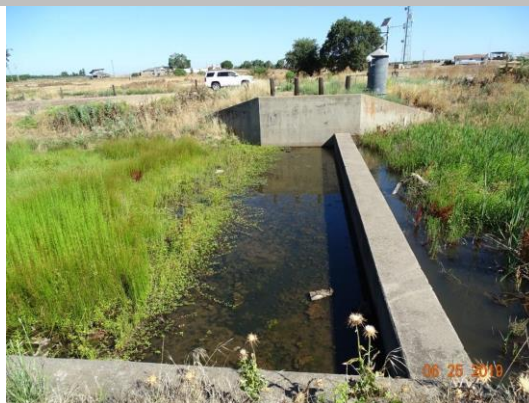
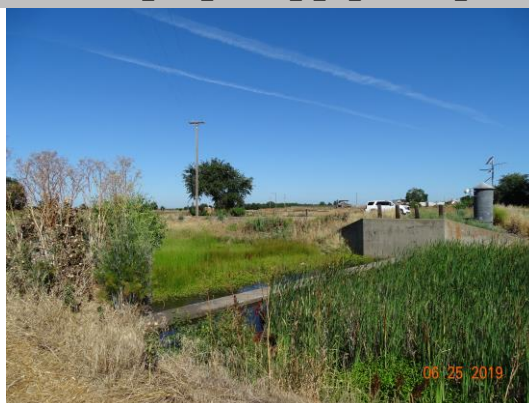
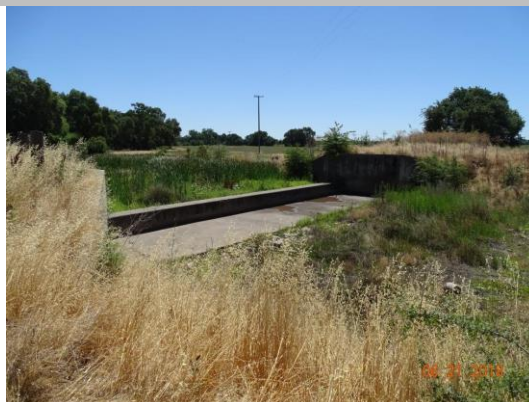
| Inspector Comments: Duck Creek Diversion Structure works as a control weir for Duck Creek and also diverts the overflow of the channel to Duck Creek Diversion channel which connects with Little John Creek. | | | | | |

View of the weir. Summer 2019

View of the weir. Summer 2018

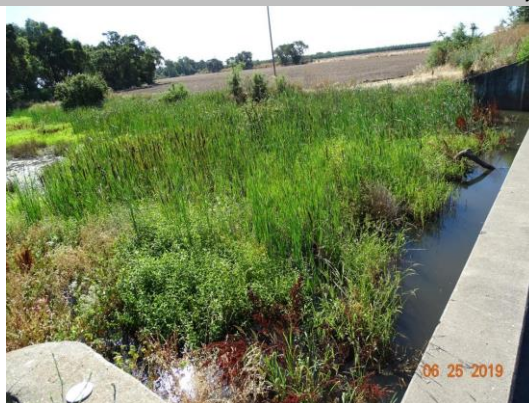
| Inspector Comments: New cat tail growth on the upstream side of the weir does not appear that it would impede flow. | | | | | |

View of vegetation looking upstream of the weir. Summer 2019

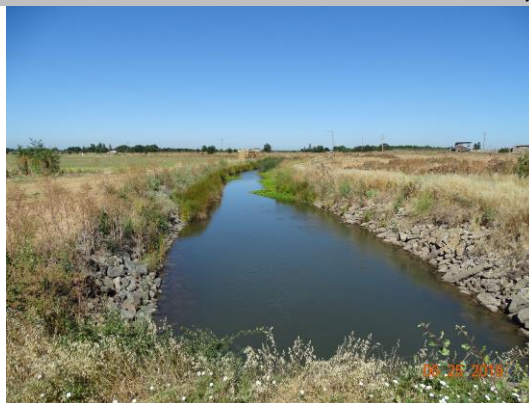
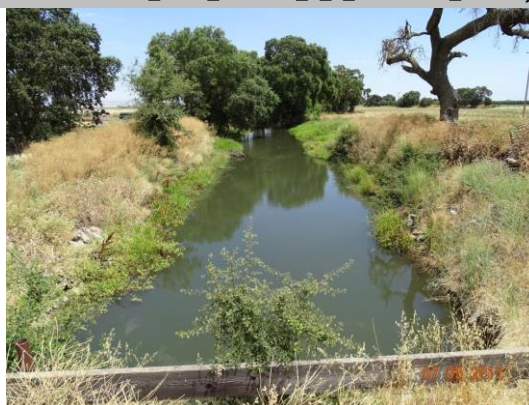
| Inspector Comments: Existing riprap protection was properly maintained. | | | | | |

View of revetment downstream of the weir. Summer 2019

View of the revetments looking upstream of the weir.

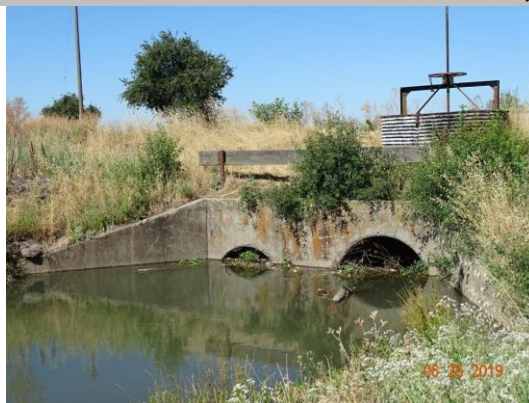
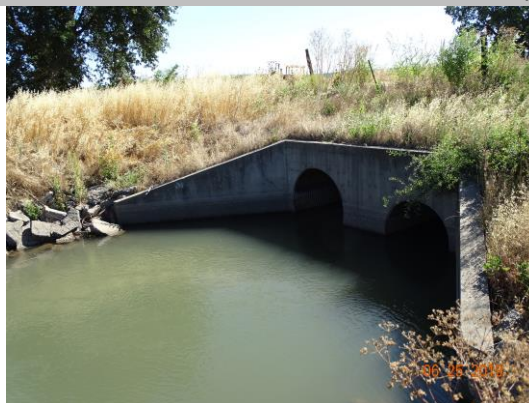
| Inspector Comments: The culvert's inlets have minor debris that should be cleared but the outlets were free of any debris. | | | | | |

View of inlets at culvert. Summer 2019

View of outlets at culvert. Summer 2019

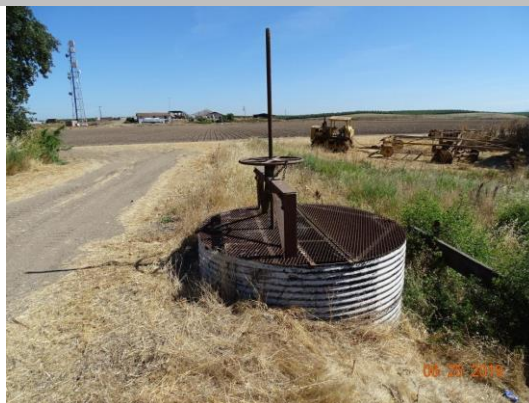
| Inspector Comments: The screw gate needs to be maintained properly so that it can be turned with ease. | | | | | |

View of the slide gate. Summer 2019

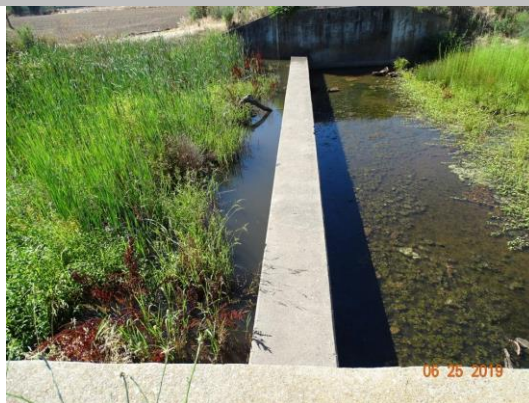
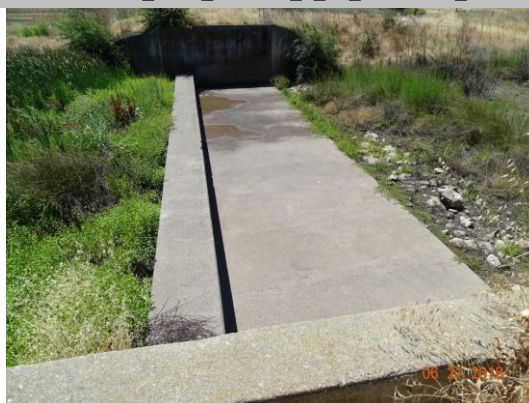
| Inspector Comments: The concrete surfaces had minor cracking and the surface was weathered but that didn't pose any threats to the integrity of the structure. | | | | | |

View of the weir and concrete surface. Summer 2019

View of the weir and the concrete surface during 2018 inspection.

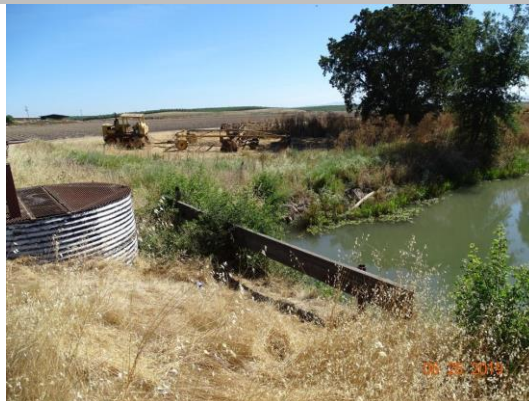
| Inspector Comments: The wood railing near the top of the culvert appeared to provide adequate protection against fall hazards. | | | | | |

View of wooden rail on top of inlet culvert. Summer 2019

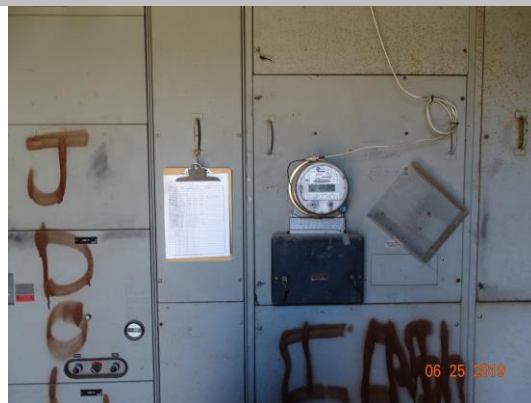
| Inspector Comments: Operating log was maintained and present at the pumping plant. | | | | | |

View of the operation log. Summer 2019

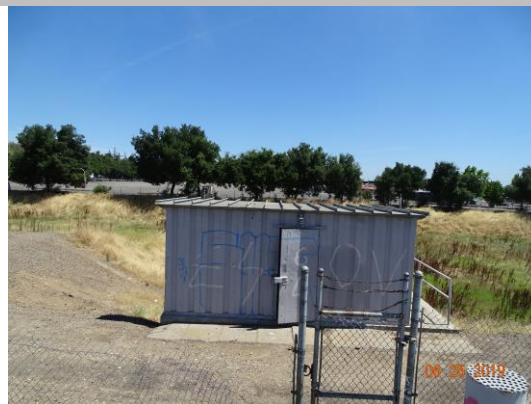
| Inspector Comments: The plant building was in good structural condition. | | | | | |

View of pumping plant. Summer 2019

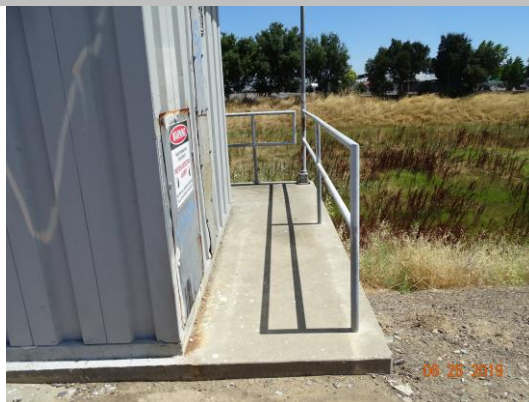
| Inspector Comments: There were no safety hazards found around the structure and the guard rails around the structure were in good condition. | | | | | | |

View of guard rails at the plant. Summer 2019

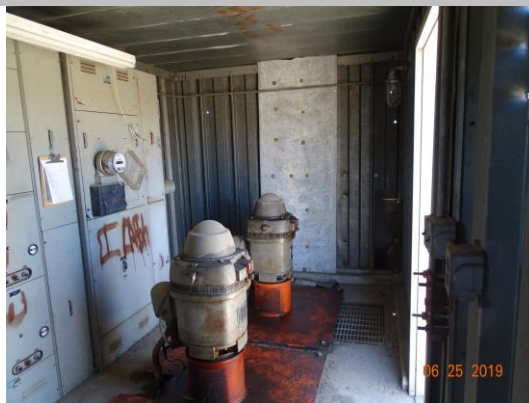
| Inspector Comments: All pumps appeared to be in working condition and they are maintained, lubricated and tested periodically. | | | | | |

View of pumps inside plant. Summer 2019

View of the shaft under a pump.

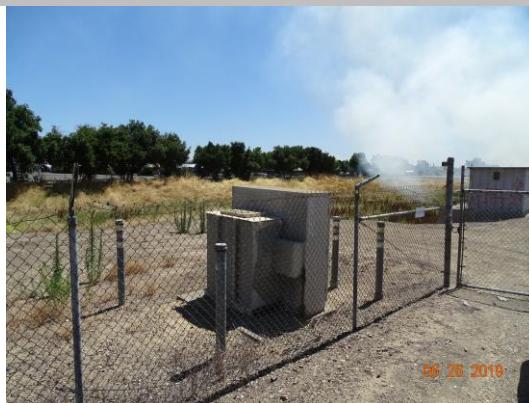
| Inspector Comments: The power source appeared to be safe and reliable. | | | | | |

View of power source next to pumping plant. Summer 2019

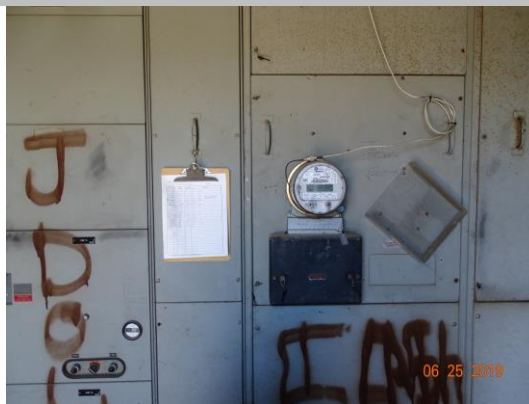
| Inspector Comments: The pump control systems were maintained properly and appeared to be free of damage. Graffiti and vandalism has caused minor property damage, however, this has not affected the operation of the the pumping plant. | | | | | |

View of pump control system and vandalism/graffiti. Summer 2019

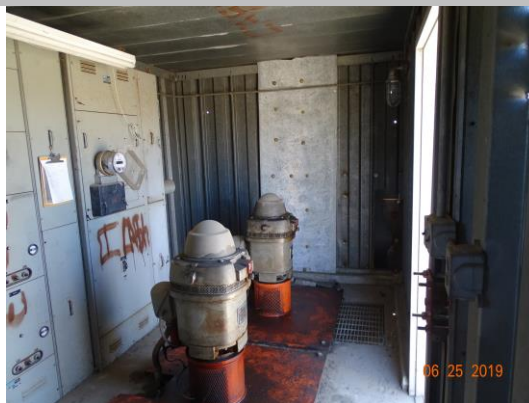
| Inspector Comments: The pump control systems were maintained properly and appeared to be free of damage. Graffiti and vandalism has caused minor property damage, however, this has not affected the operation of the the pumping plant. | | | | | | |

View of pump control system and vandalism/graffiti. Summer 2019

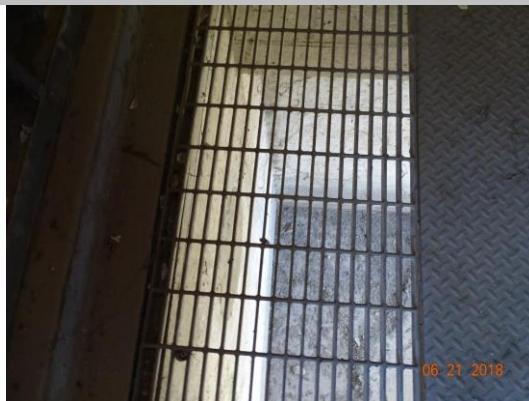
| Inspector Comments: The wet well was completely dry and very little debris was present during inspection. | | | | | |

View of the wet well.

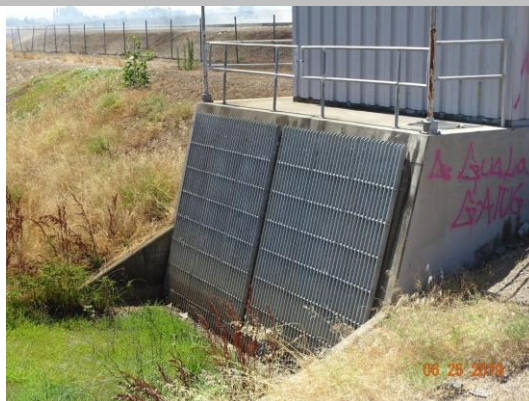
| Inspector Comments: Trash racks were properly maintained and clear of debris. | | | | | |

View of trash racks. Summer 2019

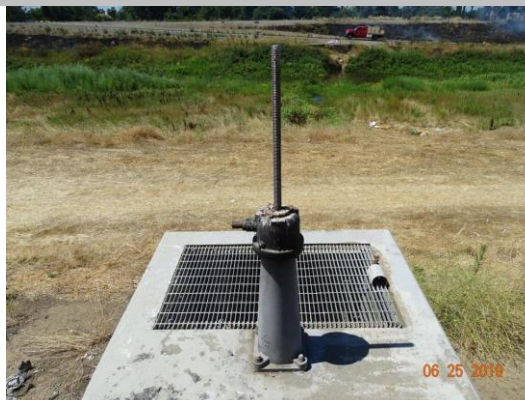
| Inspector Comments: The slide gate appeared to be in good condition. | | | | | |

View of slide gate. Summer 2019

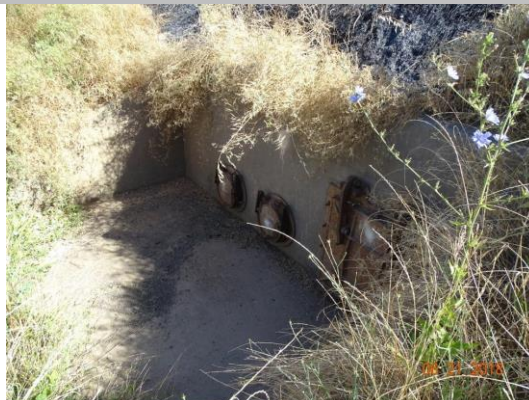
| Inspector Comments: The flap gates appeared to be in good working condition. Verified by San Joaquin County staff. | | | | | |

View of the flap gates during 2018 inspection.

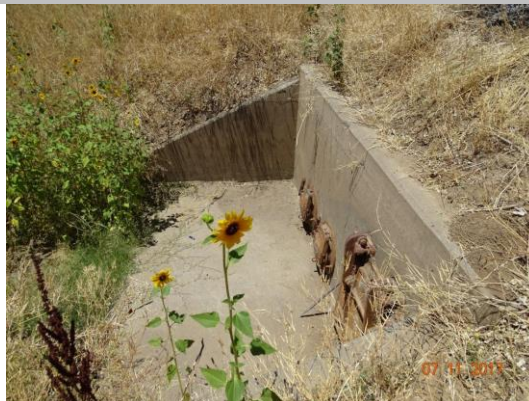
| Inspector Comments: The flap gates appeared to be in good working condition. Verified by San Joaquin County staff. | | | | | | |

View of the flap gates during 2017 inspection.

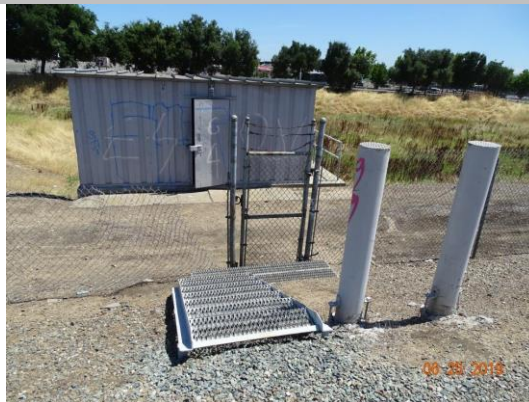
| Inspector Comments: LMA has replaced the stolen security fence from 2018 however part of the fence near the gate post has been cut allowing unauthorized access and needs to be repaired. | | | | | |

View of damaged fence near main gate. Summer 2019

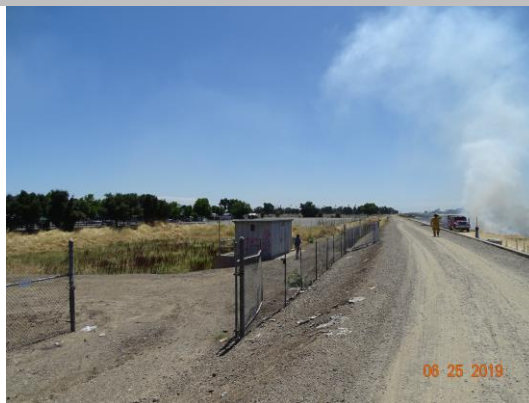
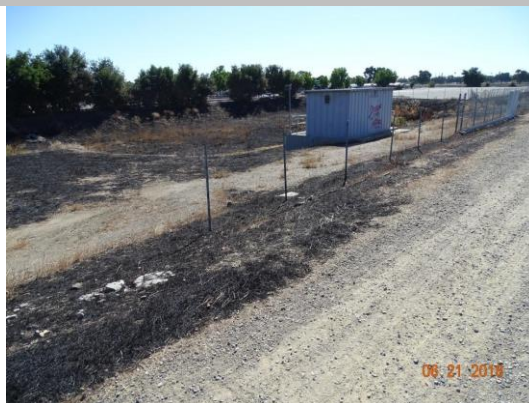
| Inspector Comments: LMA has replaced the stolen security fence from 2018 however part of the fence near the gate post has been cut allowing unauthorized access and needs to be repaired. | | | | | |

View of fence at pumping plant. Summer 2019

View of missing fence links next to the pumping plant. Summer 2018

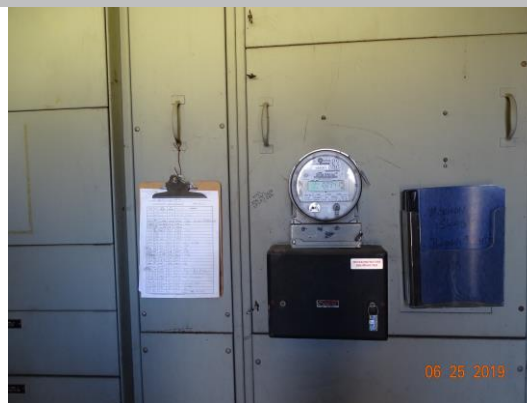
| Inspector Comments: O&M Manual was found inside the plant during the inspection. | | | | | |

View of O&M manual inside the plant. Summer 2019

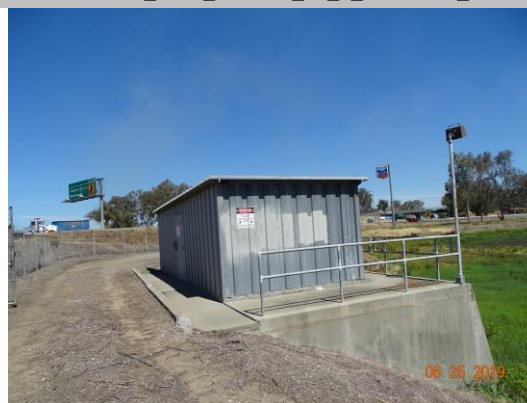
| Inspector Comments: The plant building was in good structural condition without any major deficiencies. | | | | | |

View of the pumping plant. Summer 2019

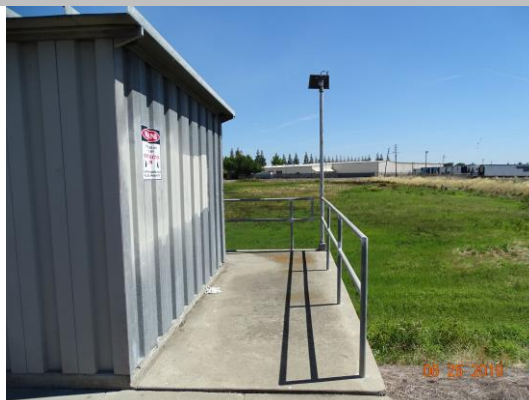
| Inspector Comments: No safety hazard was found around the structure. All hand rails were in working condition. | | | | | |

View of hand rails around the pumping plant. Summer 2019

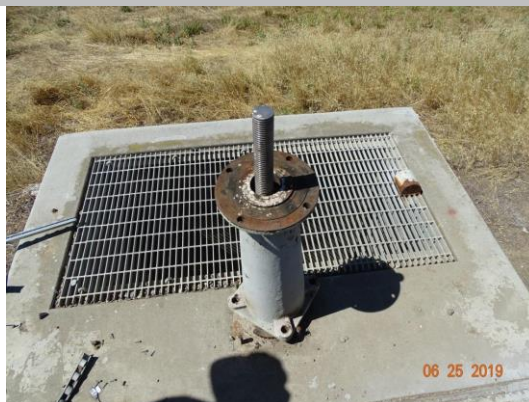
| Inspector Comments: Due to vandalism, the housing to operate the slide gate is damaged and requires repair. | | | | | |

View of slide gate in need of repair. Summer 2019

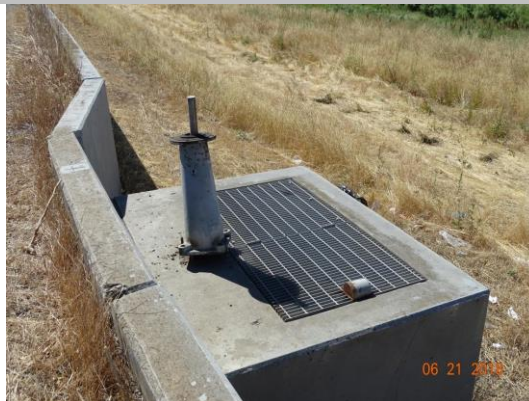
| Inspector Comments: Due to vandalism, the housing to operate the slide gate is damaged and requires repair. | | | | | | |

View of the slide gate.

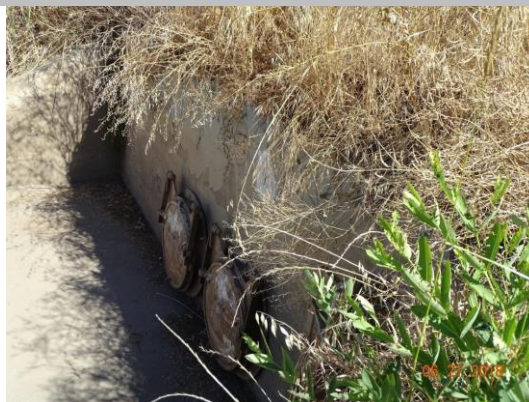
| Inspector Comments: Flap gates are in good condition and showed no damage. | | | | | |

View of the flap gates for the pumping plant.

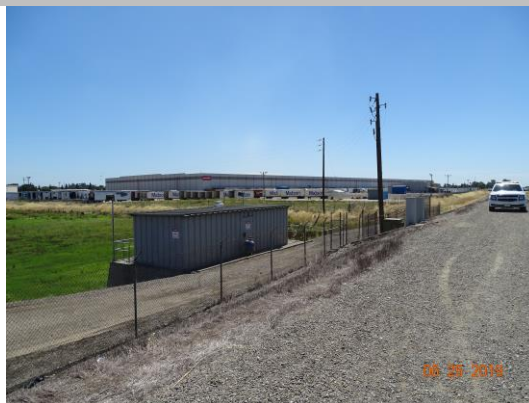
| Inspector Comments: Security fencing was in good condition without any damage. | | | | | |

View of the security fencing. Summer 2019

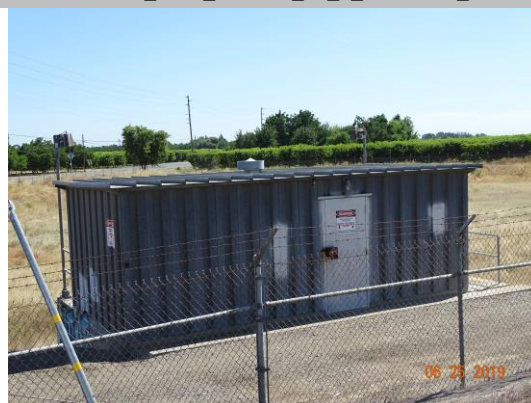
| Inspector Comments: The plant building appeared to be in good structural condition. | | | | | |

View of pumping plant. Summer 2019

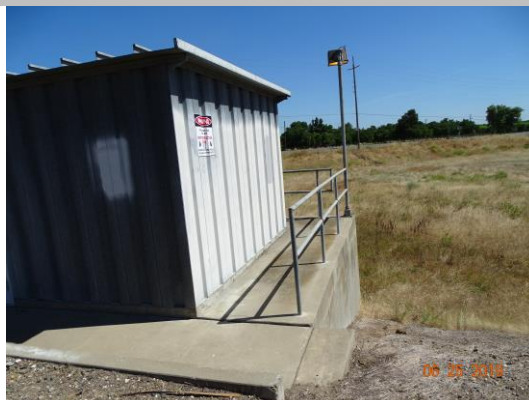
| Inspector Comments: No safety hazard was found around the pumping plant and the guard rails around the plant were in good condition. | | | | | |

View of guard rails around the pumping plant. Summer 2019

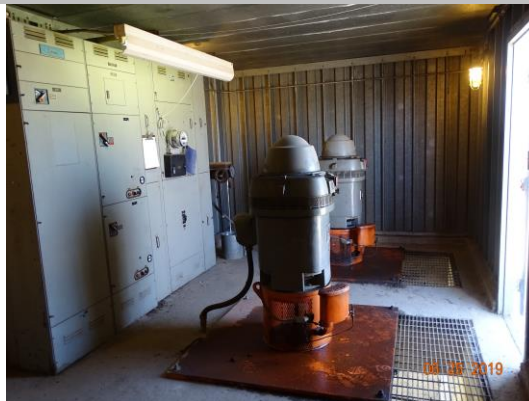
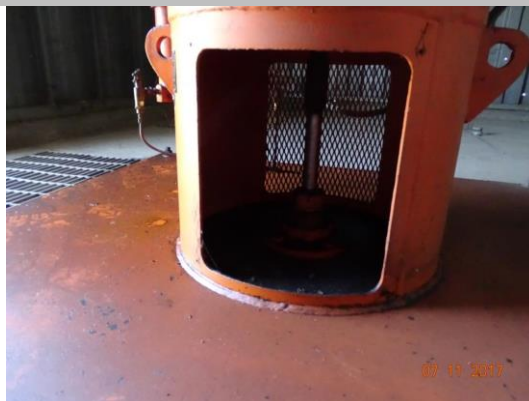
| Inspector Comments: All pumps appeared to be in good condition and maintained properly. | | | | | |

View of the pumps inside the pumping plant. Summer 2019

View of bottom shaft of one of the pumps inside the plant.

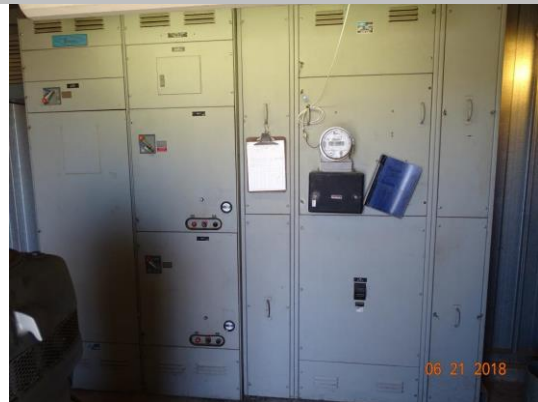
| Inspector Comments: The pump control system appeared to be operational and free of damage. | | | | | |

View of the power control systems inside the plant.

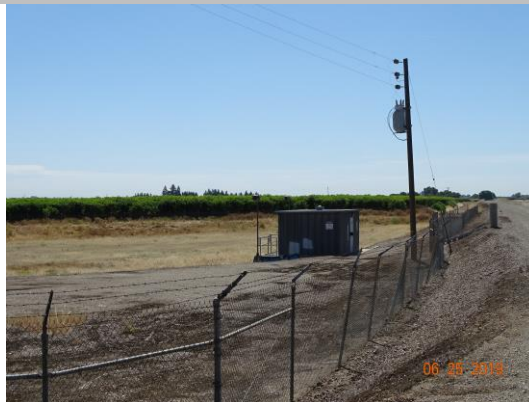
| Inspector Comments: Security fencing is in good condition. | | | | | |

View of the security fencing. Summer 2019
